# An Operators View on Approaches to MIC Threat and Failure Assessment

Presentation by: Trevor Place, Senior Eng. Specialist  
Enbridge Pipelines

**Forum on Assessment of  
Microbiologically Influenced Corrosion  
(MIC) Threats and Failures:  
Approaches and Challenges**

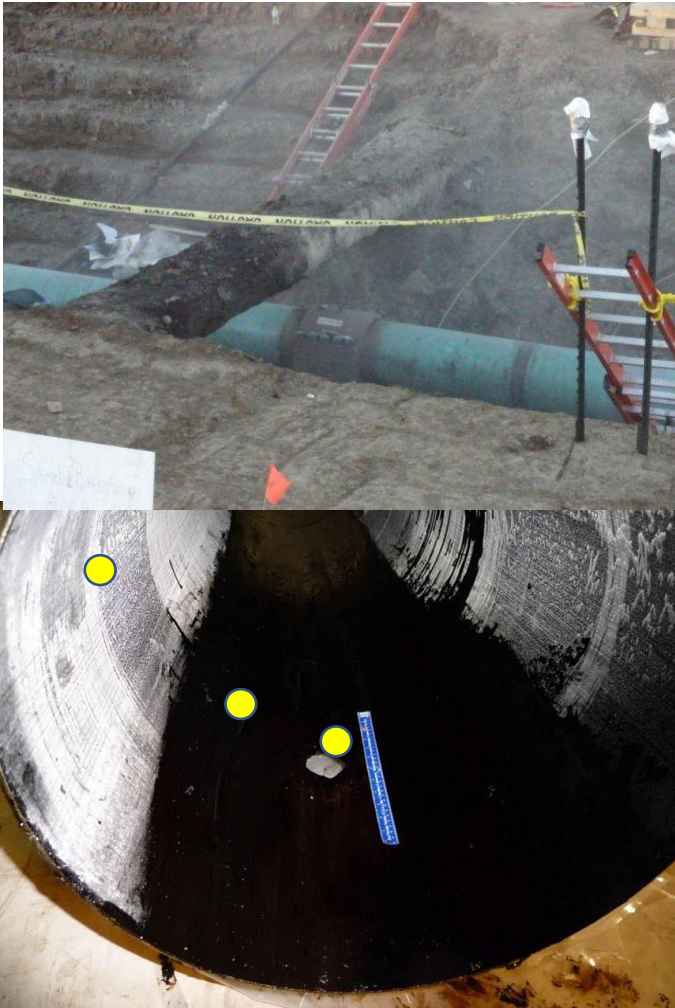
# Case Study – 1 (2012)

- Relief piping (~no flow)
- 6.35mm w.t.
- 19 years old
- Relative low spot (utility underpass)
- Lots of bacteria on bottom
  - Culture / microscopy
- More APB at leak compared to all other locations

- Dead leg, low spot, UDC
- MIC considered 'likely'

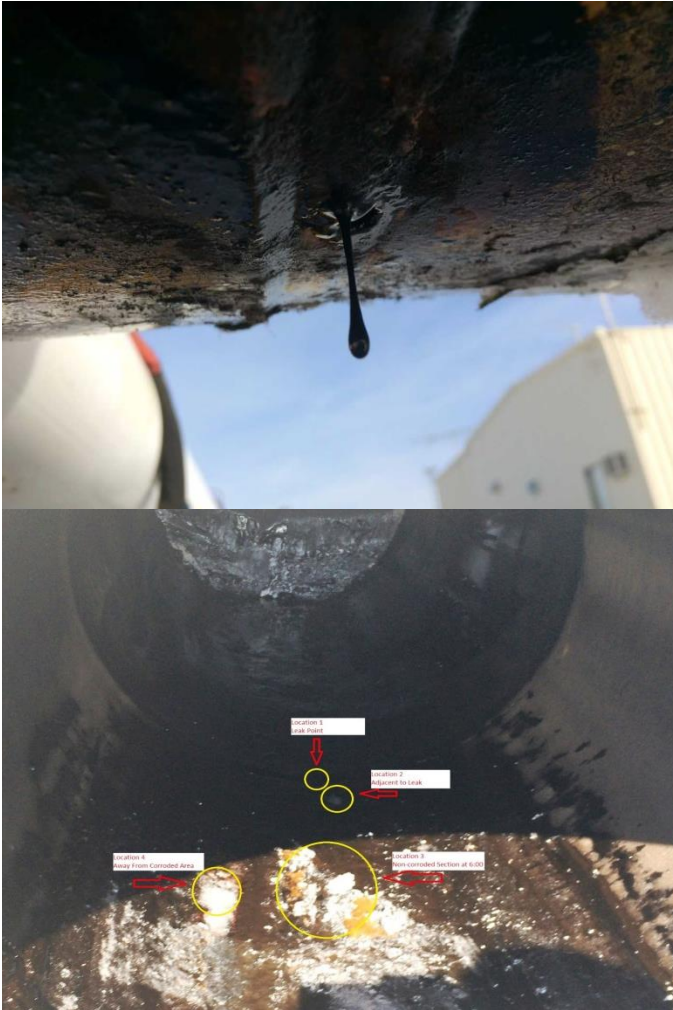
# Case Study – 2 (2017)

- Manifold end (~no flow)
- mm w.t.
- years old
- Enhanced investigation:
  - Careful sampling
  - Preservation/storage
  - Expediting to lab
  - Clear/simple instructions
  - (some luck)

Analysis of Field Samples				Laboratory Cultures	
Location	pH	Iron (mM)	Acetate (mM)	XRD	Sulphate consumption	Pitting severity
Leak site	6.92	343	17.26	FeCO <sub>3</sub> : 45-55% Fe <sub>9</sub> S <sub>8</sub> : ND Fe: ND CaCO <sub>3</sub> : 1-8%	3 mM/month	Most severe
Adjacent location	6.95	57	20.59	FeCO <sub>3</sub> : 20-30% Fe <sub>9</sub> S <sub>8</sub> : ND Fe: 1-10% CaCO <sub>3</sub> : 25-35%	2 mM/month	Moderate
Non-corroded area	6.67	12	2.42	FeCO <sub>3</sub> : ND Fe <sub>9</sub> S <sub>8</sub> : 1-10% Fe: ND CaCO <sub>3</sub> : 1-10%	1 mM/month	None

- Fermentative organisms producing organic acids figured prominently
- Biofilm formers also present in large numbers
- Organisms associated with EMIC were present (at lower numbers), and may have contributed to the corrosion at this site
