A Regulator's View on Approaches to MIC Threat and Failure Assessment

Presentation by: Jenny Been, National Energy Board

**Forum on Assessment of
Microbiologically Influenced Corrosion
(MIC) Threats and Failures:
Approaches and Challenges**

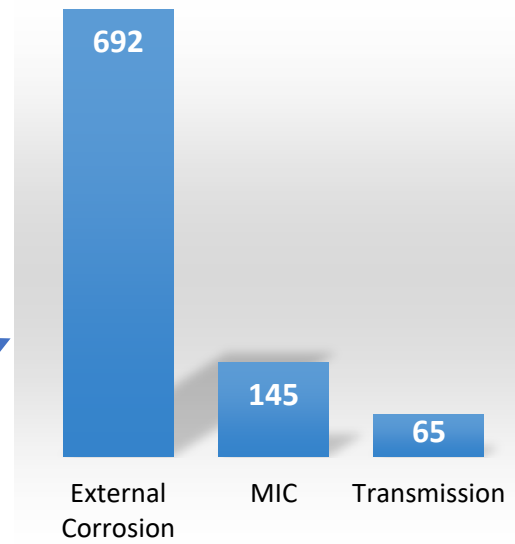
2002 to 2009

PHMSA Incident Data – Hazardous Liquid Pipelines

- Other Incident Causes
- Internal Corrosion
- External Corrosion

Overall:
4.8% MIC
Transmission:
2.1% MIC

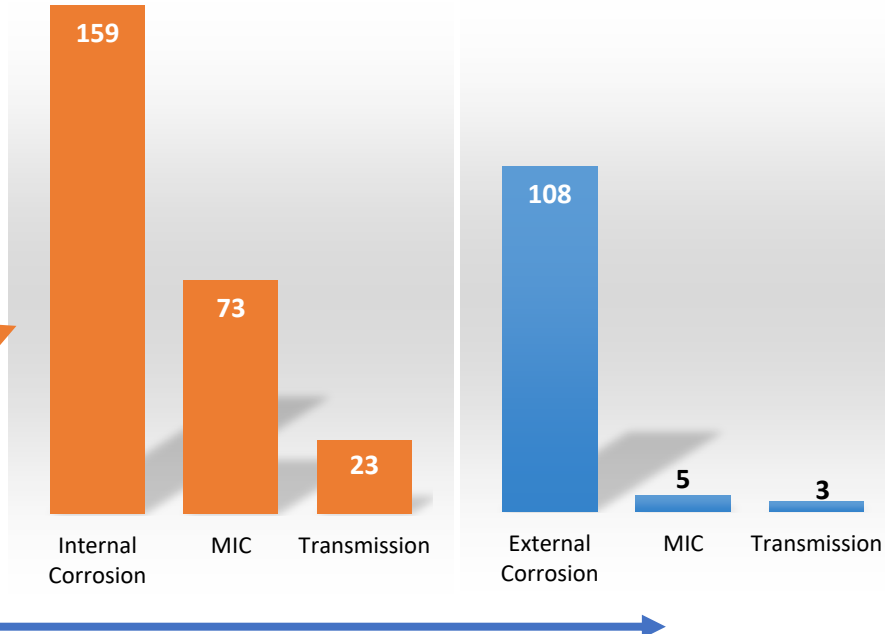
2002 to 2009

PHMSA Incident Data – Gas Pipelines

- Other Incident Causes
- Internal Corrosion
- External Corrosion

Overall: 7.6% MIC

Transmission: 2.5% MIC

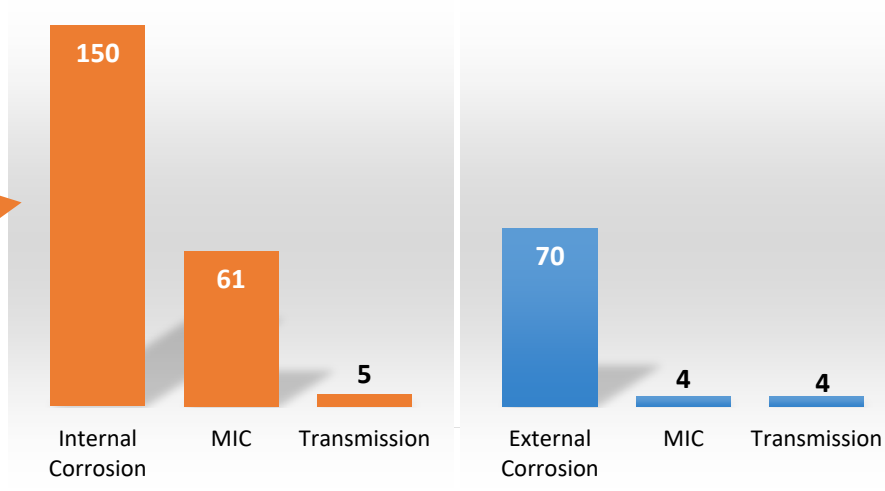
2010 to present

- Other Incident Causes
- Internal Corrosion
- External Corrosion

Overall: 6.0% MIC

Transmission: 0.8% MIC

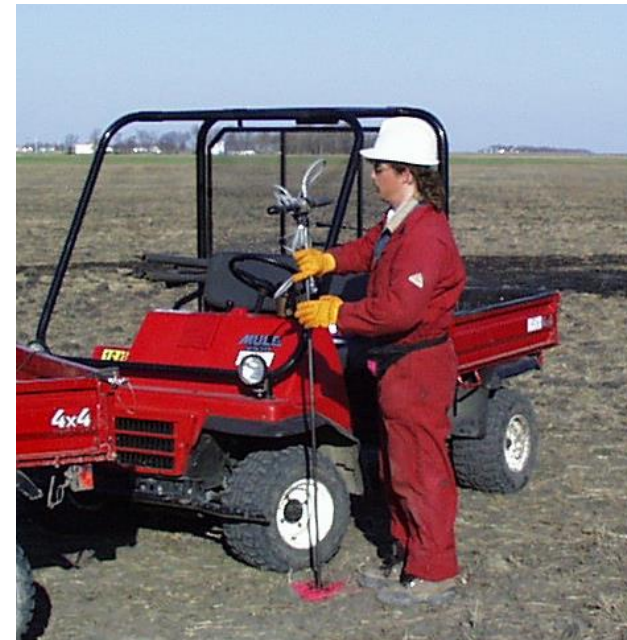
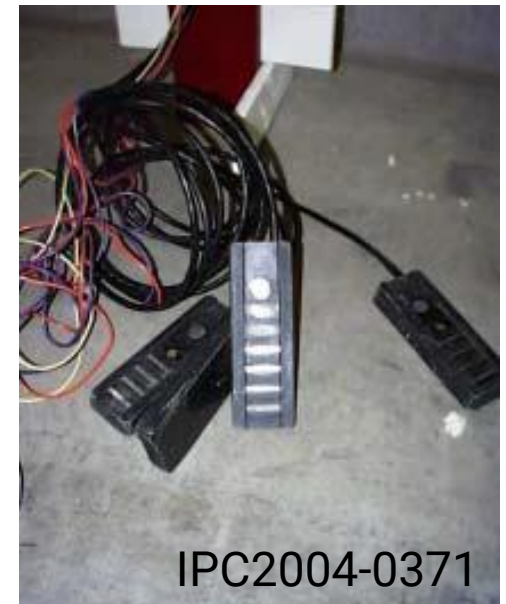
2009 Rupture of the NGTL Peace River Mainline (PRML)

- 481 km, 20-inch dia (7.14 mm wall) gas pipeline in NW AB, Class 1
- Built in 1968, field coated with PVC tape
- 1973-2009: experienced 16 leaks and 6 ruptures
- External corrosion as the predominant failure mechanism
- Operated under the jurisdiction of the ERCB (now AER) until 2009, when it moved to the jurisdiction of the NEB
- ILI and excavation program in place
- Rupture in silty soil with some clay present; considerable water at pipe depth

2009 Rupture of the NGTL PRML

- Extensive corrosion with localized areas of deep corrosion (complex corrosion geometries)
- Corrosion deposit analysis indicated the presence of iron oxide, iron carbonate, and iron sulphide (mackinawite)
- The presence of MIC thought to be primarily the result of SRB
- Supported by the presence of sulphate rich soil
- MIC was a contributing factor to the external corrosion and the rupture of PRML
- Average corrosion rates were of the order of 0.2 mm/y, where MIC may accelerate pitting rates up to 0.7 mm/y
- Increasing the CP to -1000 mV ON potential was ineffective in the presence of the disbonded shielding coating
- ILI process improvements prioritized areas of external corrosion for coating repair (2004, 2006, 2007)
